Aquatic Plant Surveys for Rice Lake, Maple Grove, Minnesota in 2006

Early Summer Survey: May 24, 2006
Late Summer Survey: August 27, 2006

Prepared for:
City of Maple Grove
Maple Grove, Minnesota

Prepared by:
Steve McComas
Jo Stuckert
Blue Water Science
(651) 690.9602

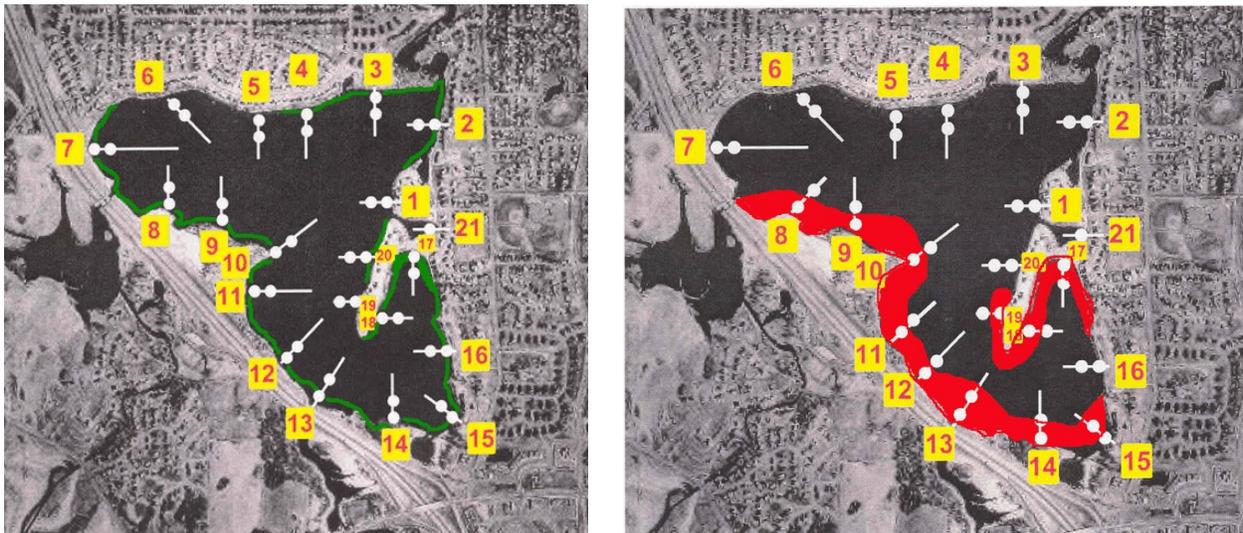
Figure 1. (left) Early summer aquatic plant coverage in 2006. Native plant coverage is shown and covers about 50 acres out of a total of 314 acres (shown in green). (right) Late summer aquatic plant coverage in 2006. The red area shows coverage of aquatic plants. Plants covered about 80 acres.

Curlyleaf pondweed covers 50 acres in early summer and then dies back. It grows sparsely and does not require control at this time. Eurasian watermilfoil was observed but is sparse and does not present a nuisance condition.

If curlyleaf grows to nuisance conditions in the future, a drawdown is recommended.

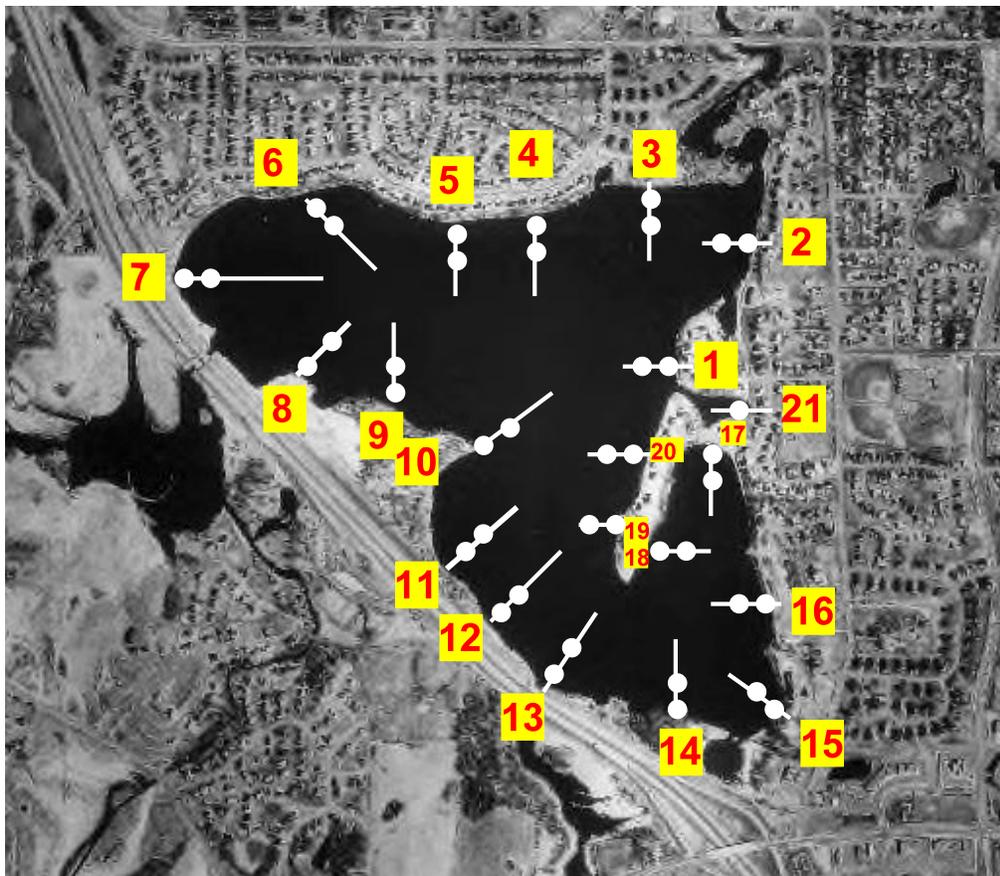
Figure 1. Transects for plant surveys on May 24 and August 27, 2006.

Several techniques were used to characterize aquatic plants in Rice Lake. We used 21 line transects (Figure 1). Two depths (0-4 feet and 5-9 feet) on a transect were randomly sampled with a rake to characterize species presence and density. A recording sonar (Lowrance X-16) was used to delineate the depths of weed colonization.

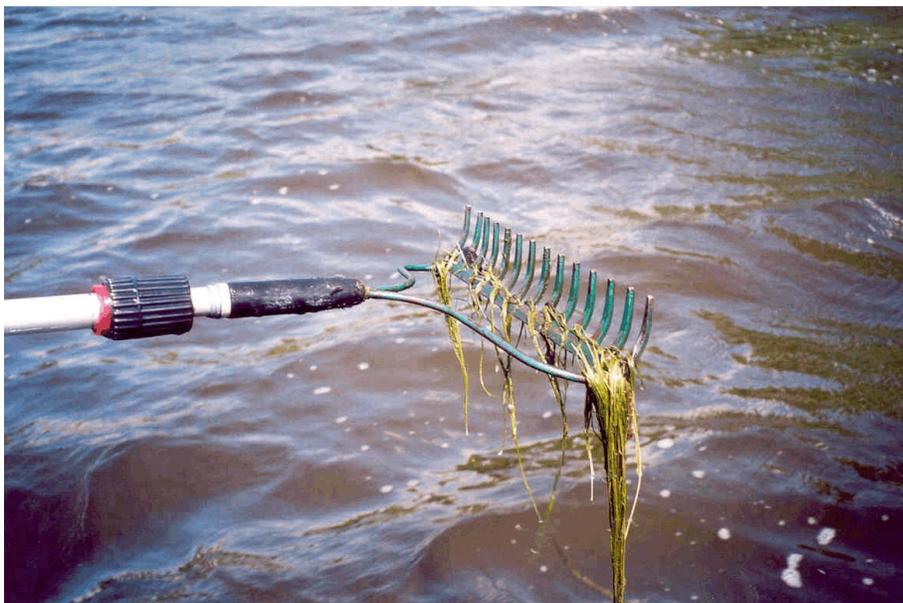
Aquatic plant density was estimated based on a scale from 1-5 with 1 being the less dense and 5 representing plants matting at the surface. An example of a plant density of a "1" and a "2" are shown in Figure 2. Plant density ratings were based on the amount of plants collected on a rake head. A single stem or a trace of an identifiable plant was rated at a density of "1". If plants were collected up to at least one half of the rake head (7 out of 14 tines) it was rated at a density of "2". If plants covered all of the rake tines, the density was a "3". If plants covered all 14 tines and was dense on all tines (even obscuring them) the density was a "4". A density of "5" was only assigned to plants matting at the surface.

Figure 2. Aquatic plants were sampled with a rake. Here is a rake with curlyleaf pondweed at a density of a "1" and stringy pondweed at a density of a "2".

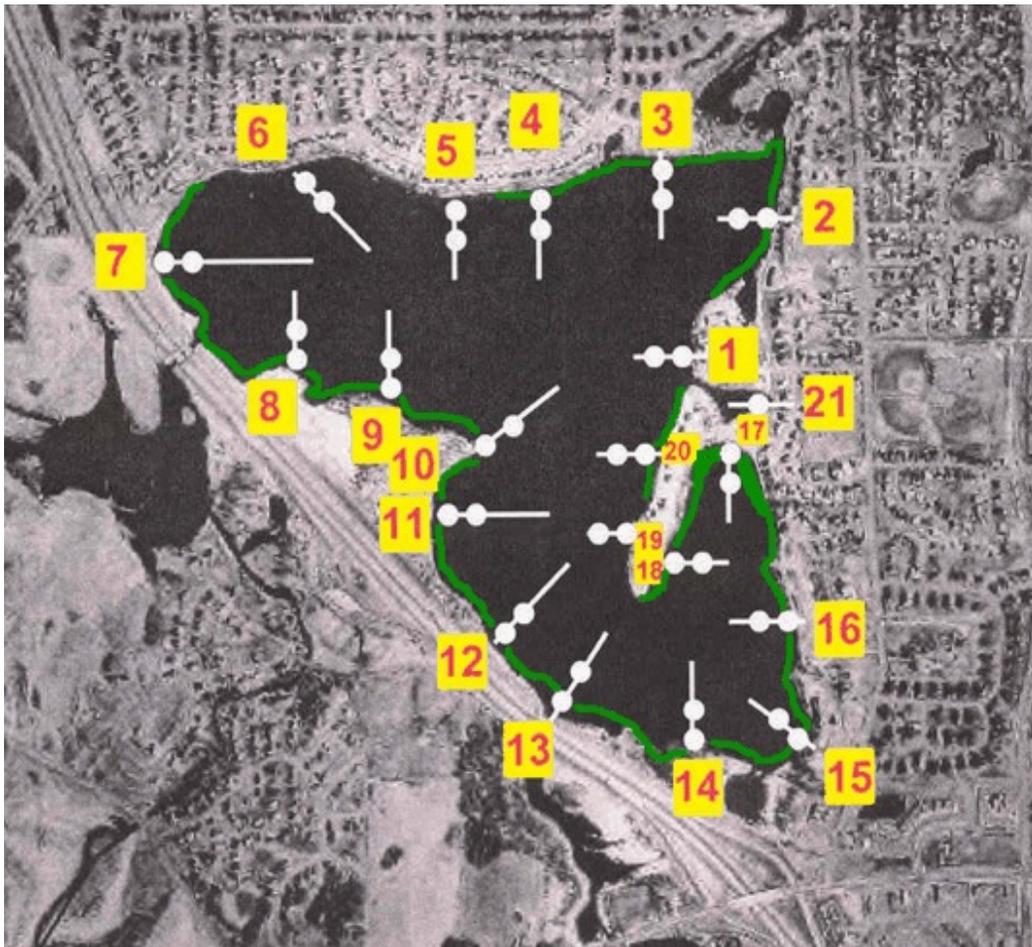
An aquatic plant coverage map is shown in Figure 3. Curlyleaf pondweed coverage is basically the same as the aquatic plant coverage map. Curlyleaf coverage is about 50 acres of the 314 acre Rice Lake.

Figure 1. Early summer aquatic plant coverage in 2006. Native plant coverage is shown and covers about 50 acres out of a total of 314 acres (shown in green).

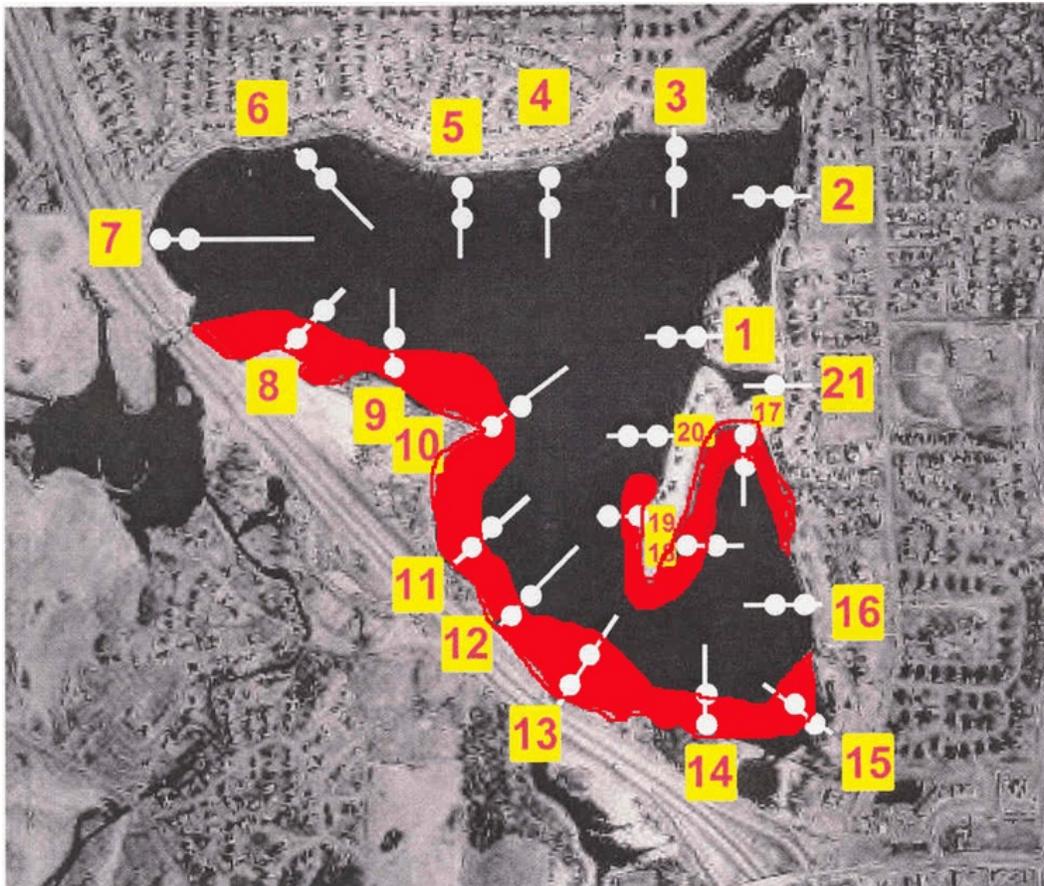
A map of aquatic plant coverage is shown in Figure 5. Aquatic plants covered about 26% of the bottom or roughly 80 acres. Within the 80 acres, submerged plants were scarce. Eurasian watermilfoil was found in this survey at three sites.

Figure 5. Late summer aquatic plant coverage in 2006. The red area shows coverage of aquatic plants. Plants covered about 80 acres.

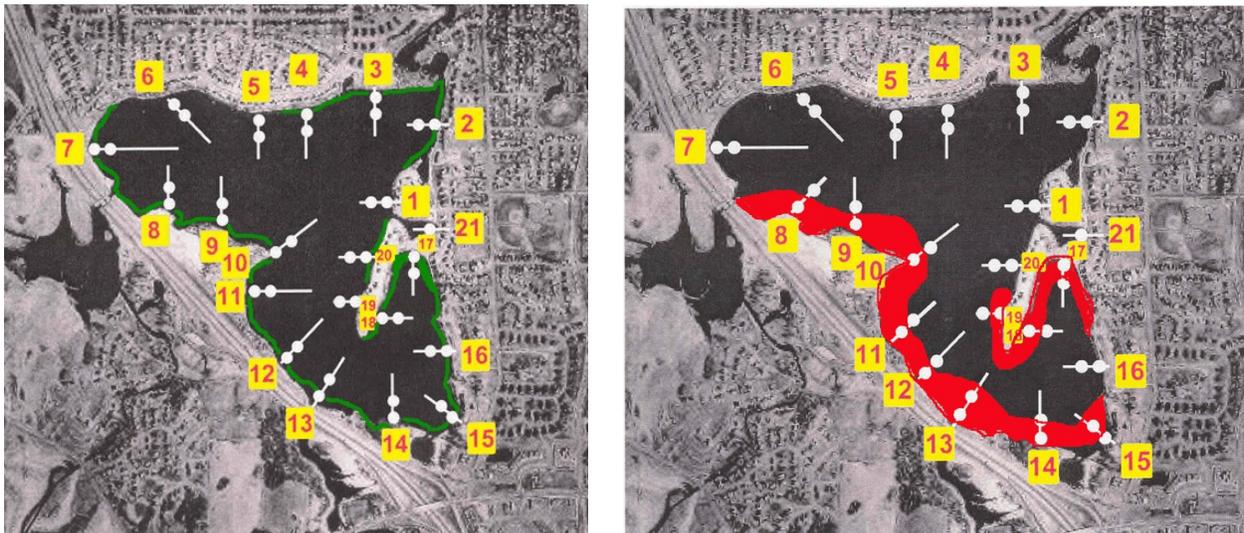
Figure 7. (left) Early summer aquatic plant coverage in 2006. Native plant coverage is shown and covers about 50 acres out of a total of 314 acres (shown in green). (right) Late summer aquatic plant coverage in 2006. The red area shows coverage of aquatic plants. Plants covered about 80 acres.

Curlyleaf pondweed covers 50 acres in early summer and then dies back. It grows sparsely and does not require control at this time. Eurasian watermilfoil was observed but is sparse and does not present a nuisance condition.

If curlyleaf grows to nuisance conditions in the future, a drawdown is recommended.
